The Holy Grail of Motor Mounts?

Background: I have a 1964 Plymouth Barracuda. It originally had a 273 CI 2-bbl engine with a A904 automatic. In about 1969 a 318 was swapped in to replace the damaged 273. In the early 80s, I swapped out the transmission for a junkyard A833 4-speed. In about 1986 I bought a used 340, made minor mods, and put it into the Barracuda. Motor mounts are always an issue!

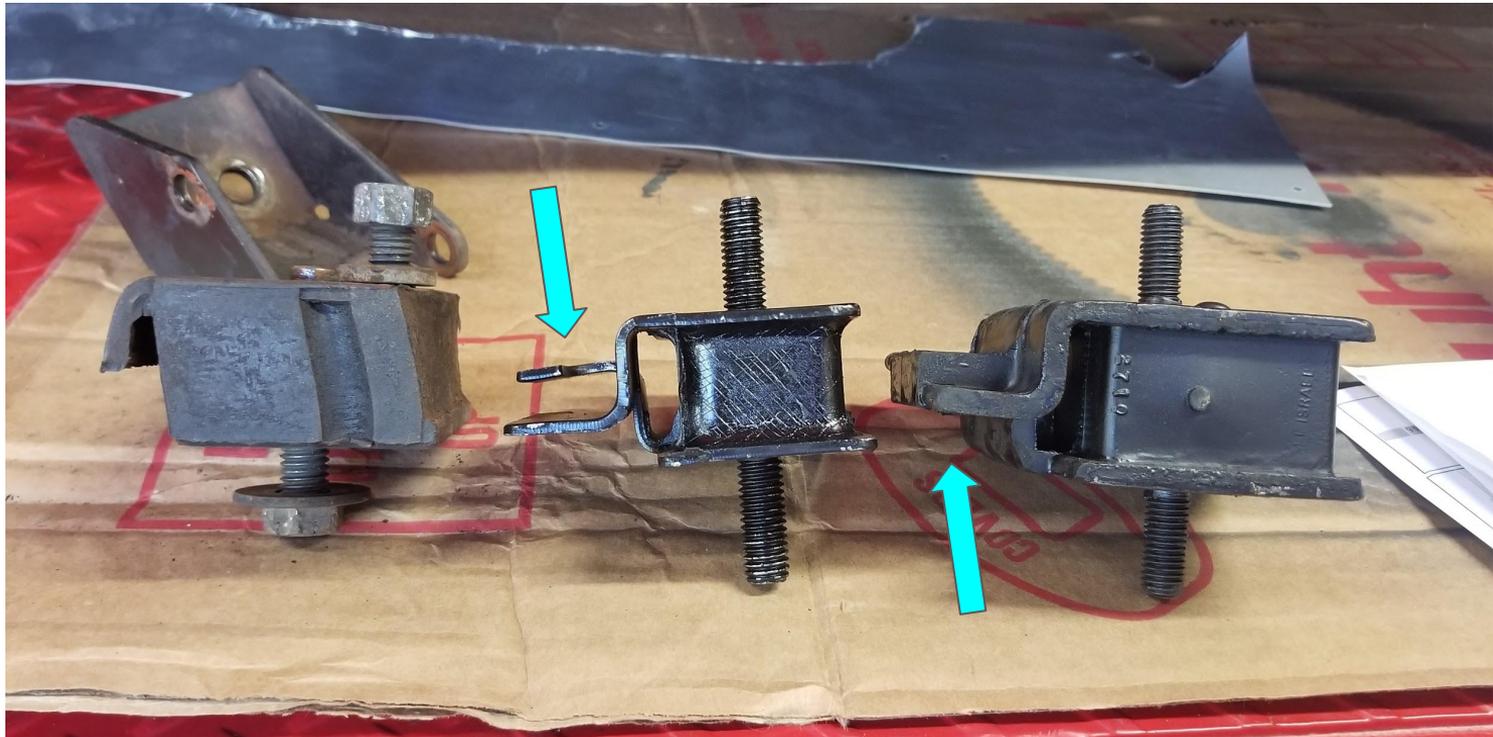
Three motor mounts below. On the left is the one that has been on the car for 30+ years. The other two have the feature that negates the need for a torque strap - those 'fingers' sticking out to the left cross over each other, preventing the isolator from tearing, or spreading more than about $\frac{1}{4}$!" The middle is the 2469 model. (These model numbers seem to be consistent across vendors, but each vendor has their own part number.) It came on a wide variety of Dodge trucks from the 70s into the 90s. The one on the right is the one I ended up using. It's the 2710 model, and one vehicle it came on is a 1990 Dodge W250. It's a diesel mount, so it's much sturdier. Also, the overlapping fingers are encased in more rubber (or whatever it is) further limiting travel.

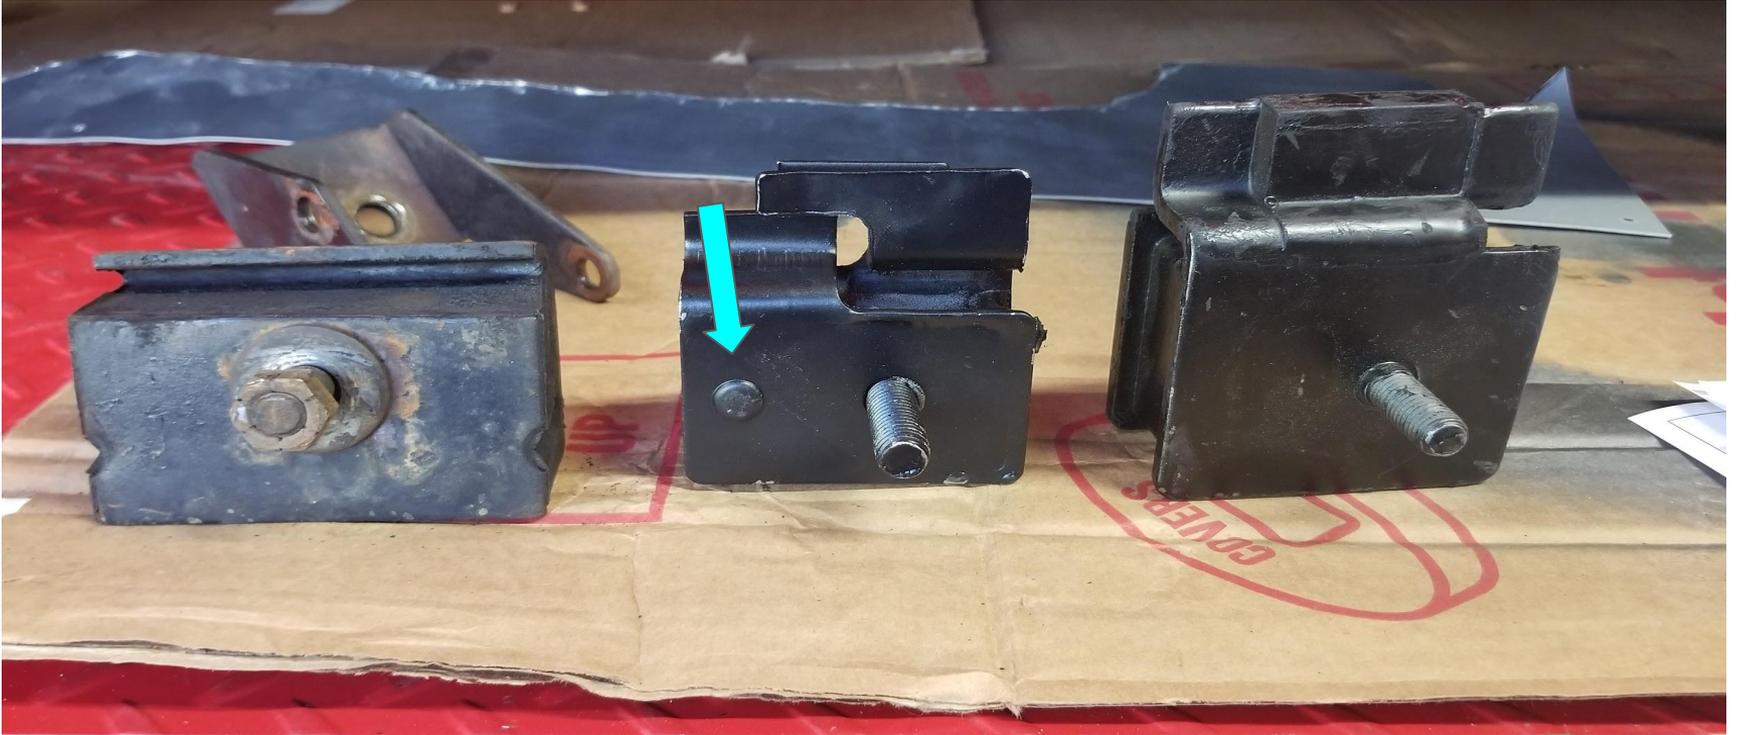
This is a different view showing the bottom of the three mounts. Note that the middle one has an extra 'button' that should have a corresponding alignment hole, but the k-member doesn't have that hole. This is another point in favor of the 2710 model on the right.

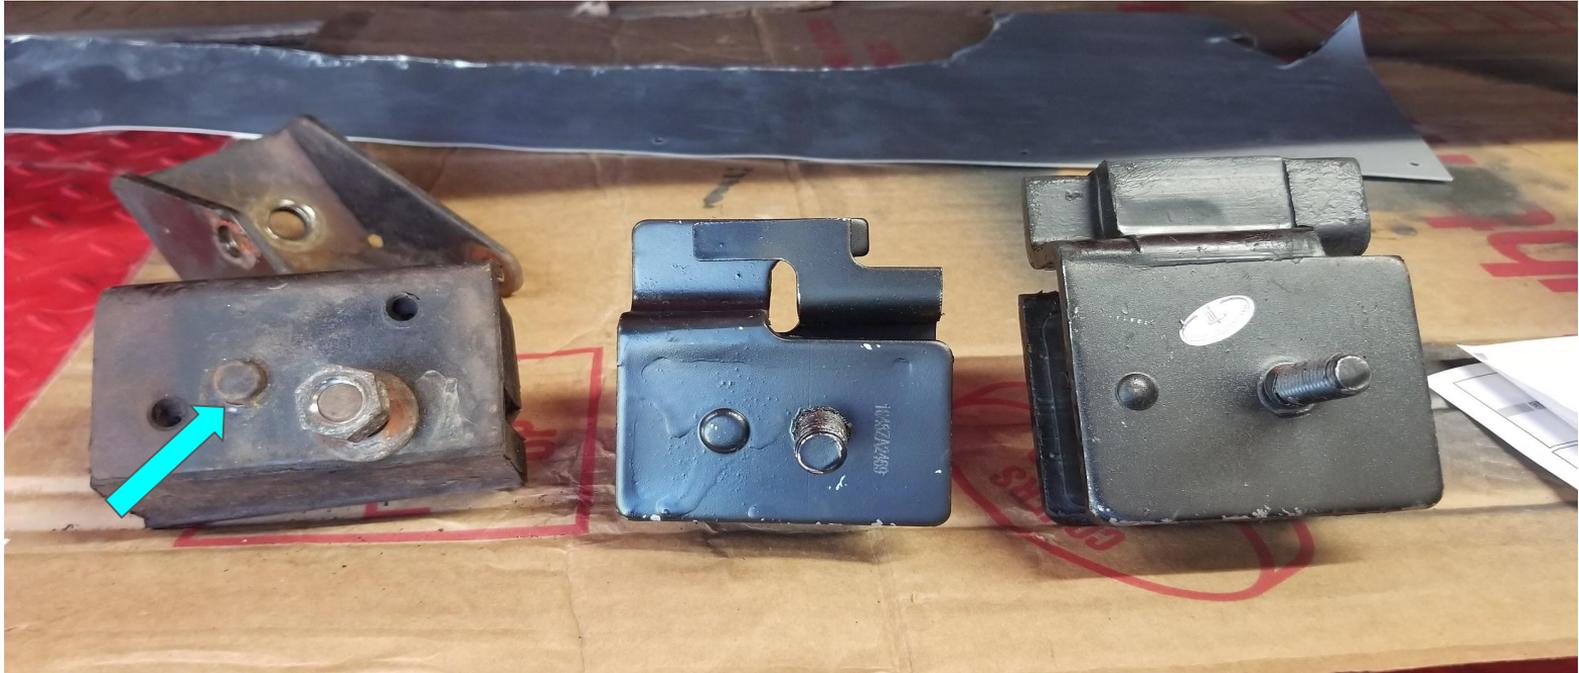
Here is a view of the top of the mounts. Note that the original one had a button diagonal from the bolt; there is a matching hole in the motor mount perch.

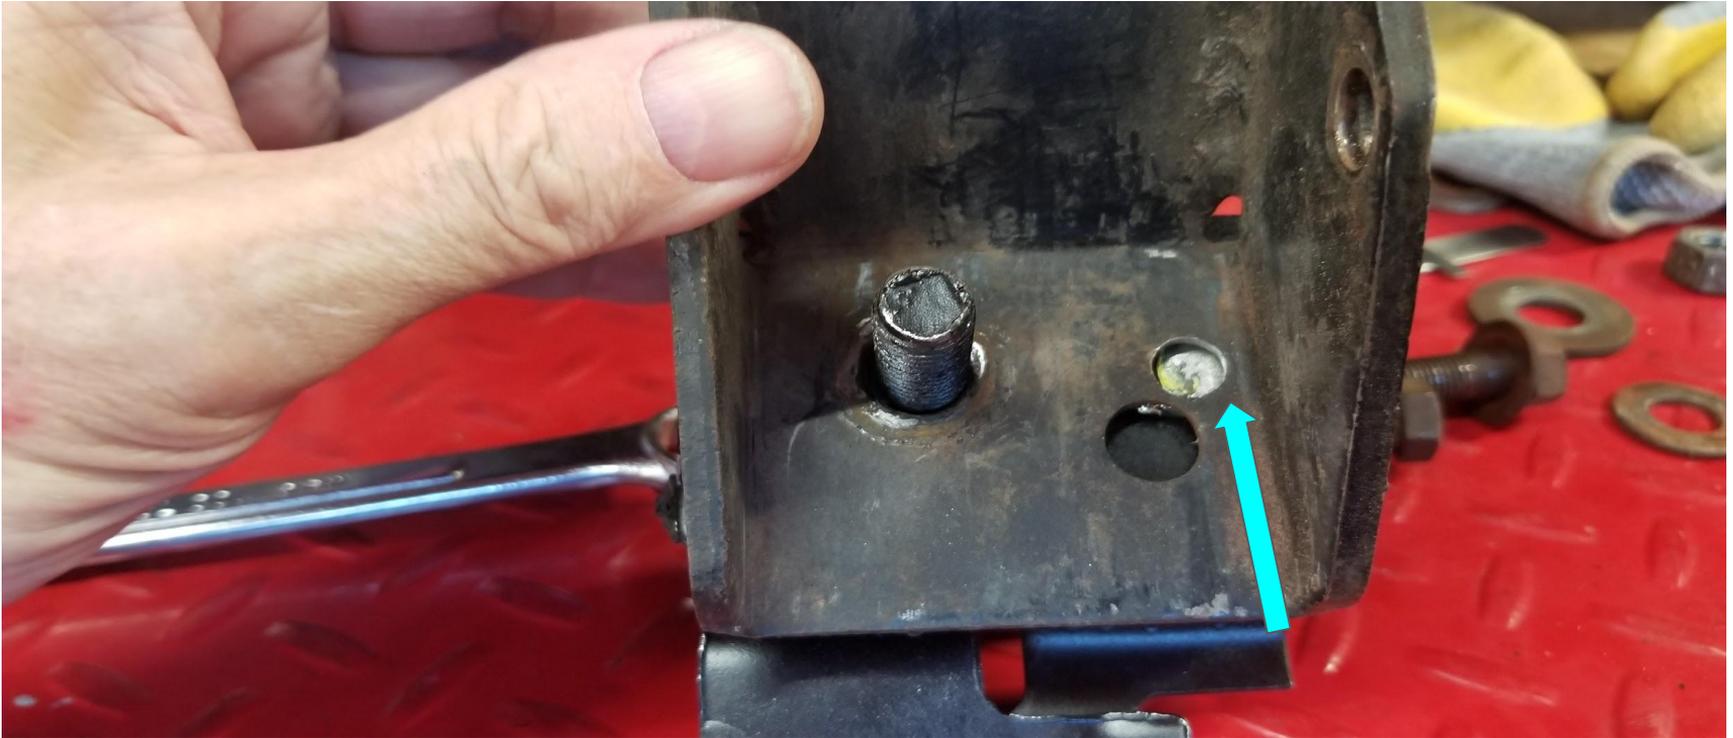
This is the driver's motor mount perch, as seen from inside the engine. (!)
Note the new hole on the right side that matches the button on the top of the 2710 mount.

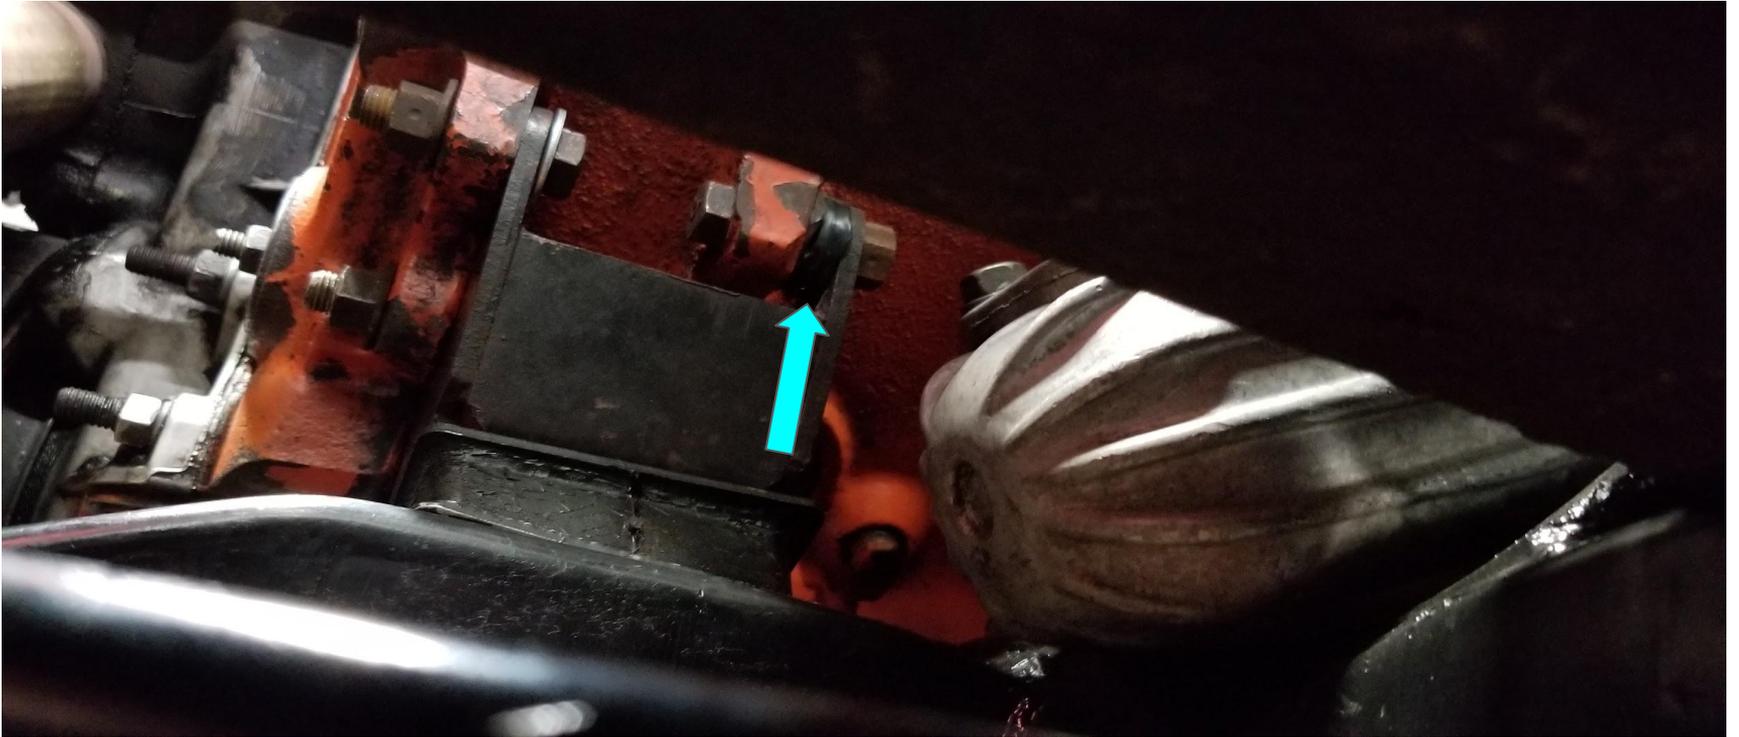
This is the 2469 model. I installed it first, but it was too soft and too short. It dropped the engine down enough that the headers interfered with the steering coupler and the driver's torsion bar!
Note the clever use of three washers wrapped in electrical tape since the mount perch wasn't designed for this engine. (It's OK though; I put it on really tight.)

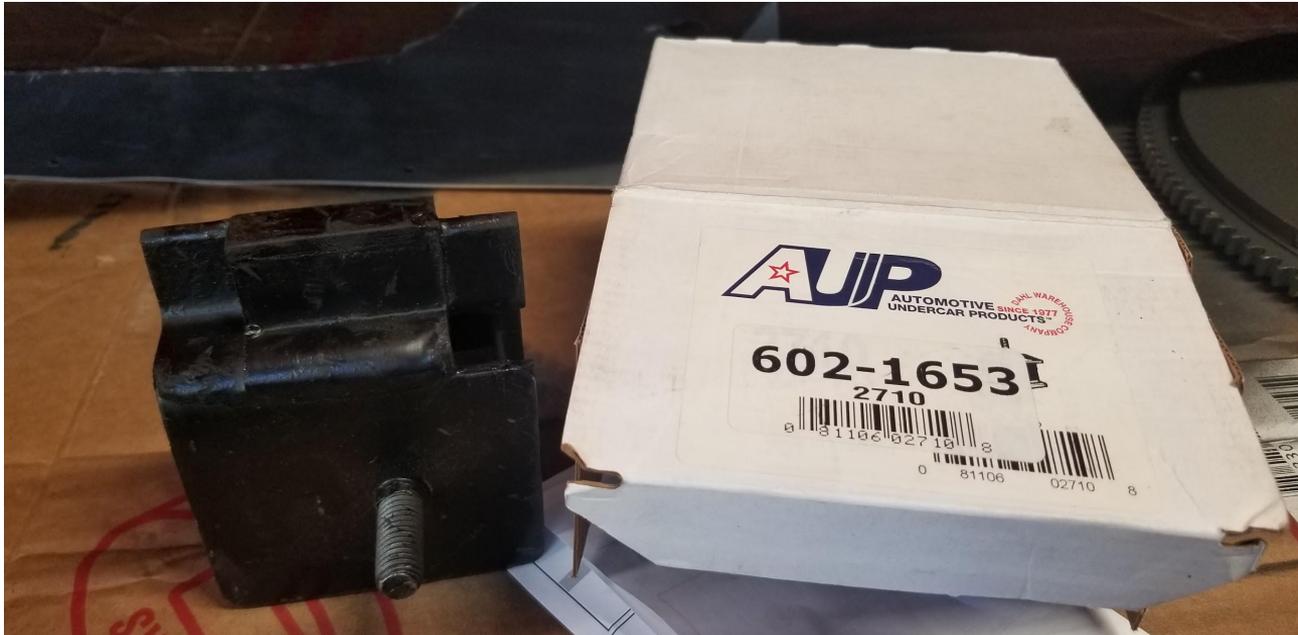
This is the mount I ended up using - I got it from my local Napa. The end result is that:

- The headers no longer hit the master cylinder on acceleration
- The headers clear everything - torsion bar, steering shaft, etc.
- There is slightly more engine vibration into the cabin than before
- There is very little movement from the new mount
- No more torque strap!
