SERVICE BULLETIN

No. 63-46

VARIABLE SPEED
WINDSHIELD
WIPER PARKING
OPERATION

1955
THROUGH
1963
IMPERIAL,
CHRYSLER,
PLYMOUTH
AND
VALIANT
MODELS

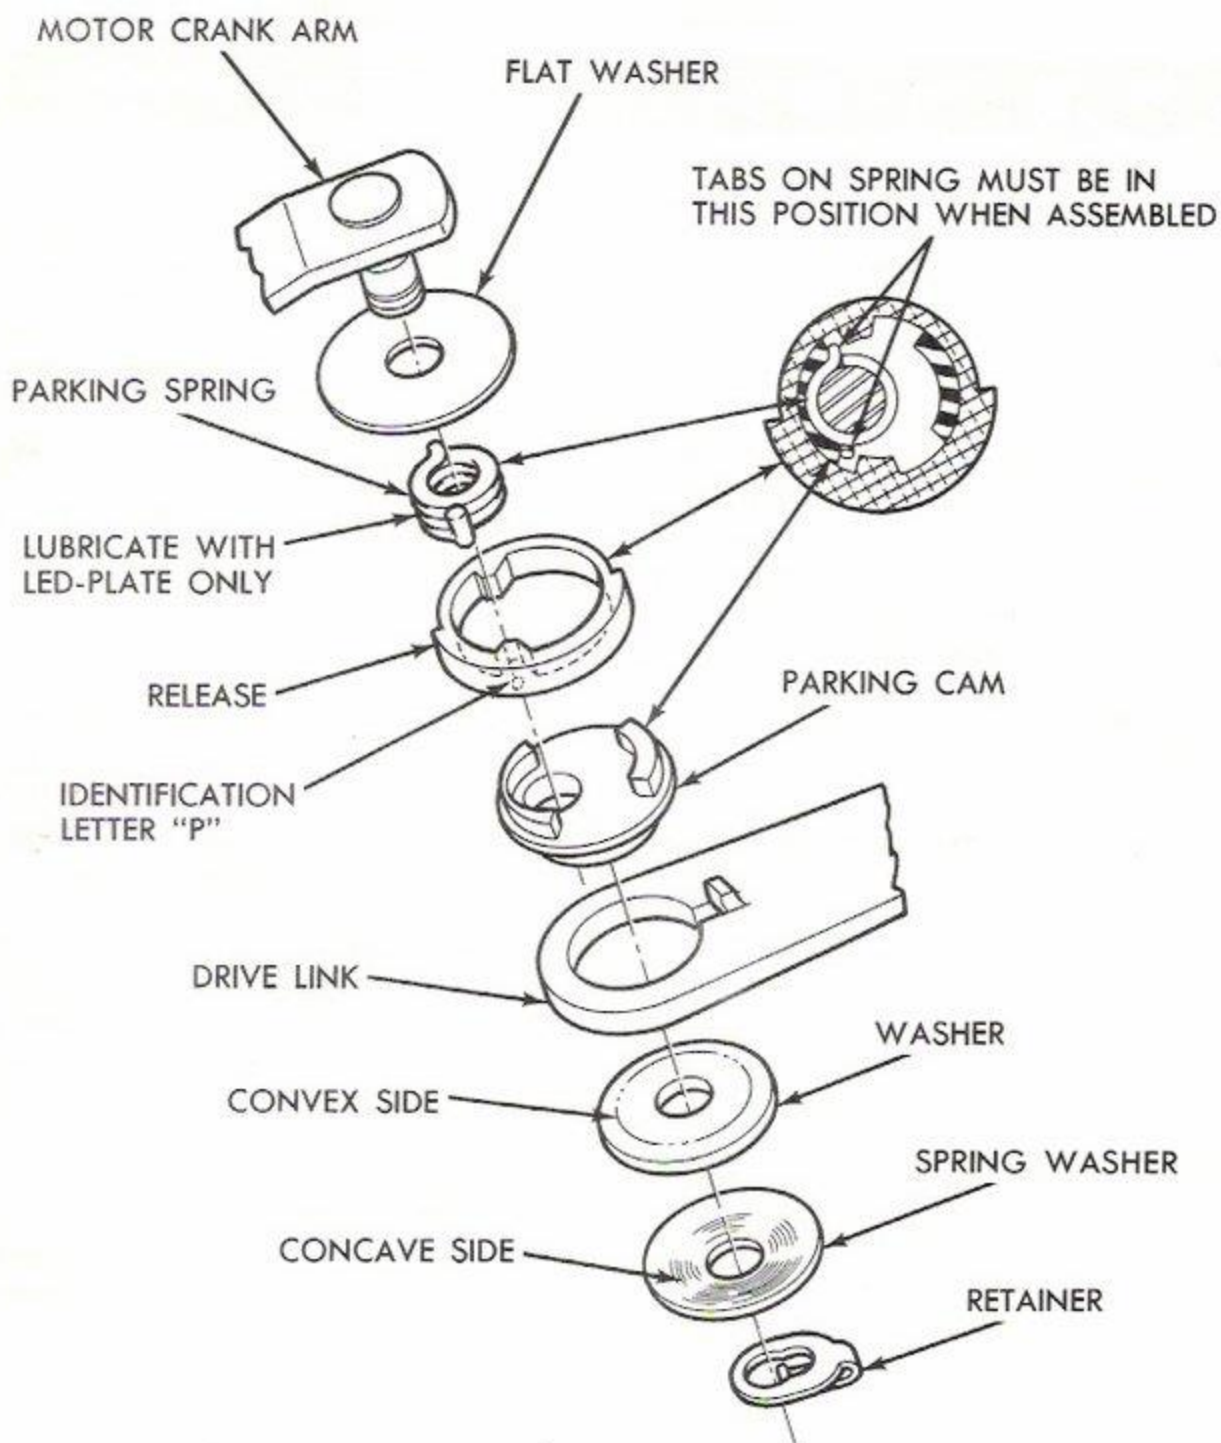
1963 VALIANT VARIABLE SPEED
WINDSHIELD WIPER PARKING MECHANISM

If at the 1/2 cycle park test the measured travel of the wiper blades from the normal wipe pattern to the park position is less than two (2") inches, improper operation of the parking mechanism is indicated. On the 1963 Valiant model wiper system, improper operation of the parking mechanism may be caused by incorrect assembly of the parking spring release and the parking cam.

It is possible to assemble the components in a number of different ways that will give improper parking, but still allow the balance of the system to operate normally. However, this will only happen when the switch "shut off" is timed at a point for more than one cycle travel to the park position. Therefore, it is essential to use the 1/2 cycle park test, subjecting the parking mechanism to the most severe test of its operating ability.

For correct assembly sequence of the park mechanism components, refer to the illustration on page 3 of this bulletin.
