SERVICE BULLETIN

No. 63-49

ELECTRIC WINDOW LIFT WIRING

1963
IMPERIAL,
CHRYSLER
AND
PLYMOUTH
MODELS
EQUIPPED
WITH
POWER
WINDOWS

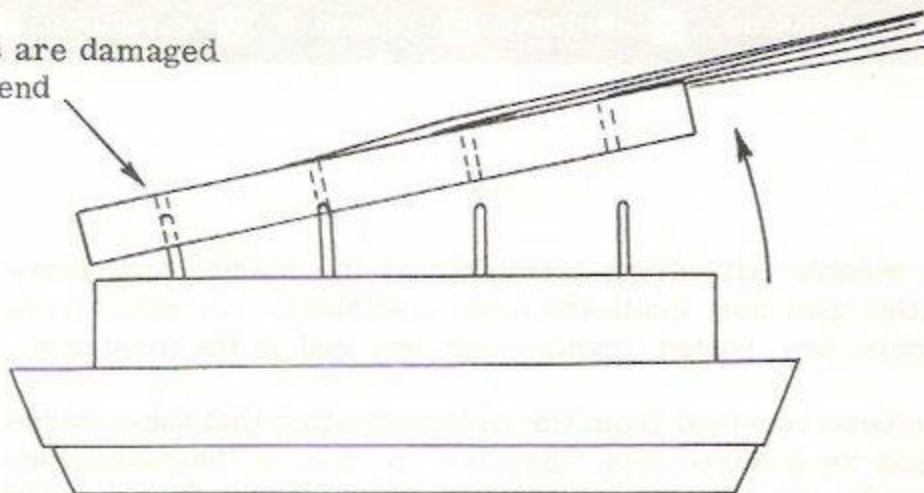
A

Reports have been received from the field indicating that these wires are being used as a convenient "handle" to remove the connectors from the switch. Connectors removed in this manner do not come straight off the switch. The connectors pivot at the switch pins at the end of the switch opposite the wire "handle" (feed wire end). This rotation of the terminals on the pins causes permanent distortion of the terminals resulting in open circuits and premature switch failure. Refer to "A" in the illustration on the back of this bulletin.

Terminals are damaged
at this end

IMPROPER REMOVAL

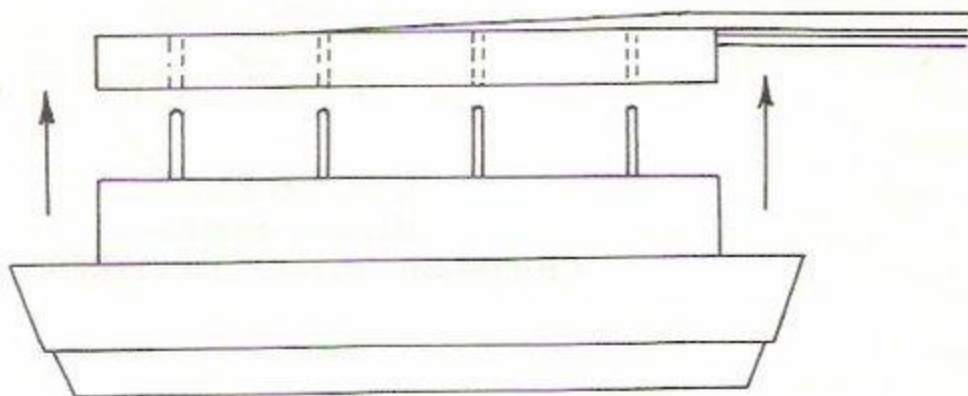
B

PROPER REMOVAL

IMPORTANT: Always remove the electric window lift master switch connectors straight off the switch in the manner indicated in "B" in the illustration.
